Concrete Pavement Rehabilitation Manual

May, 1992

WISCONSIN DEPARTMENT OF TRANSPORTATION
Division of Highways
Central Office Materials
Pavement Section

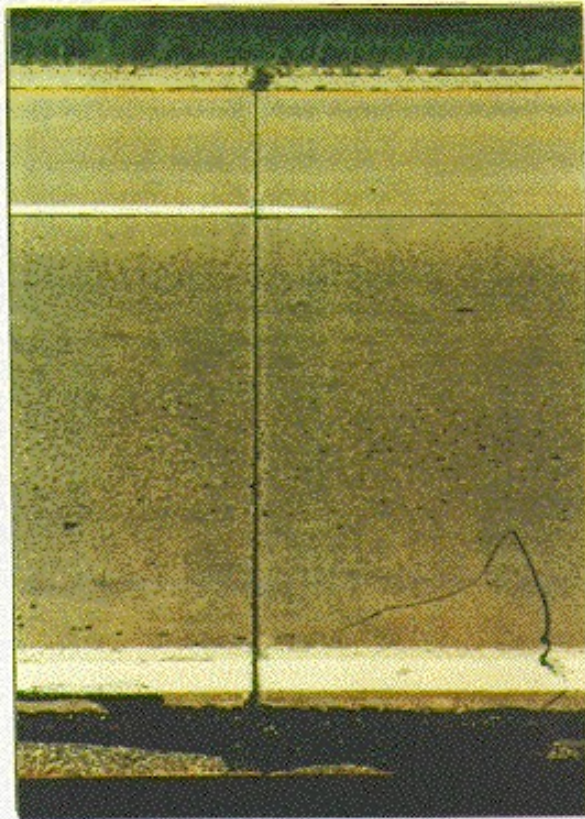
1. JOINT

Joint is in excellent condition. No repair required.

Same.

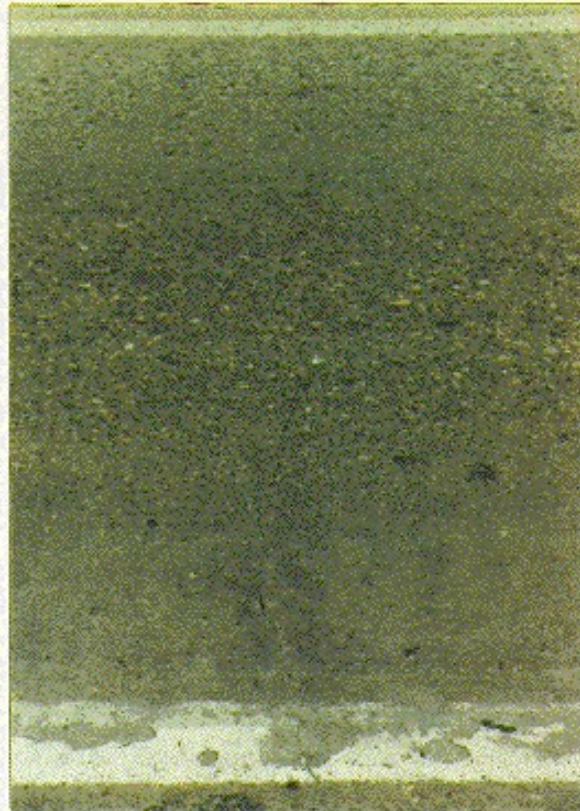
6. CRACK

This hairline crack requires no attention regardless of rehabilitation strategy.

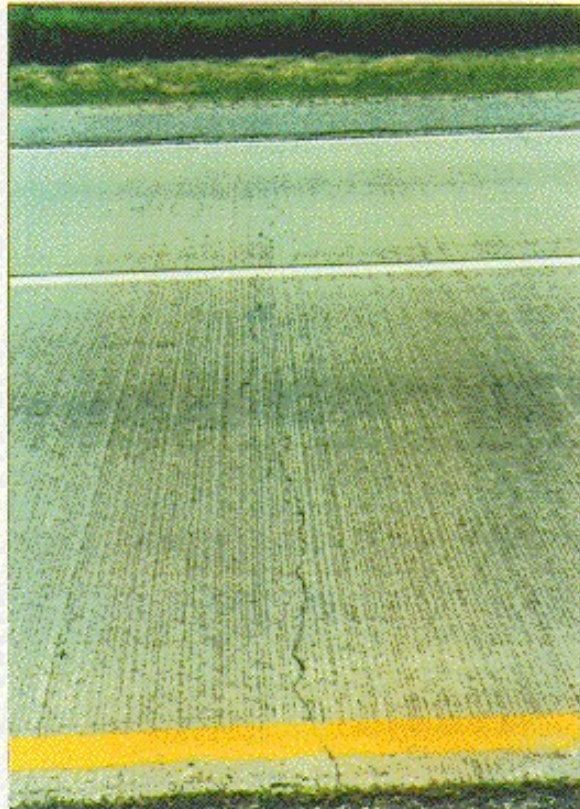
1. Single Transverse Crack

This crack requires no attention regardless of rehabilitation strategy. This is a typical crack for CRCP pavements and it normally occurs at 3-10 foot intervals.

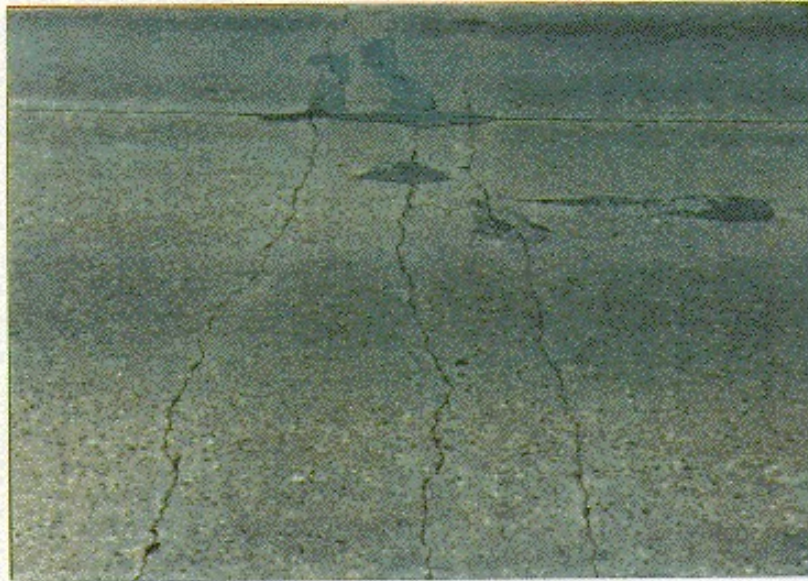
3. Multiple Transverse Cracks

This series of cracks does not require repair. They are all still tight with insignificant spalling. Close inspection of the CRCP is required here. The presence of longitudinal cracking must be determined here. The confirmation of the existence or nonexistence of the longitudinal cracking is important to assure performance of the repair.

These cracks do not require repair as part of this rehabilitation alternative.

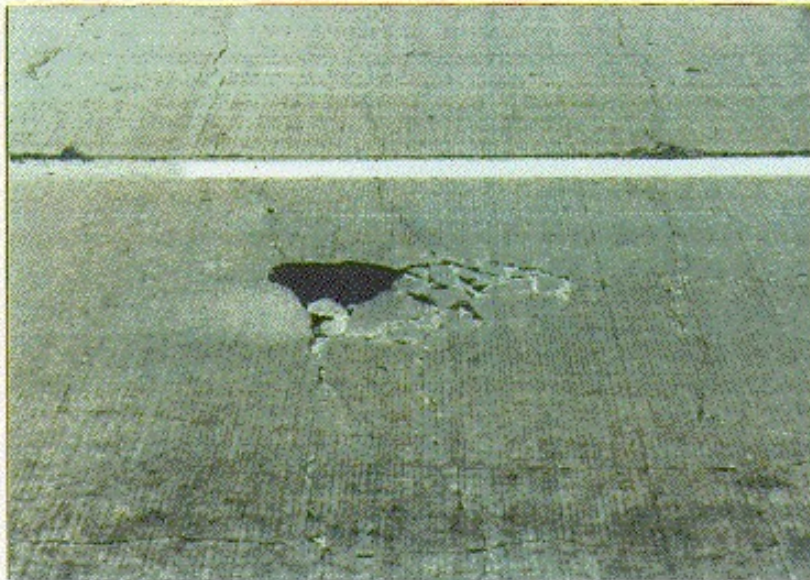
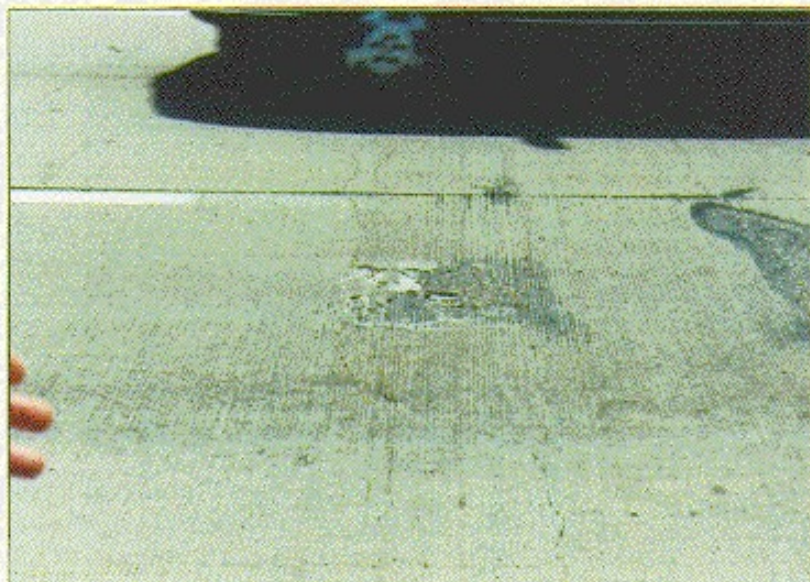
5. Deteriorated Areas

These deteriorated areas require repair as part of this rehabilitation strategy.

A determination of the extent of the deterioration must be made. If the deterioration is full depth a full depth repair is required. If it is partial depth a partial depth repair with either AC or PCC is required prior to placement of the overlay.

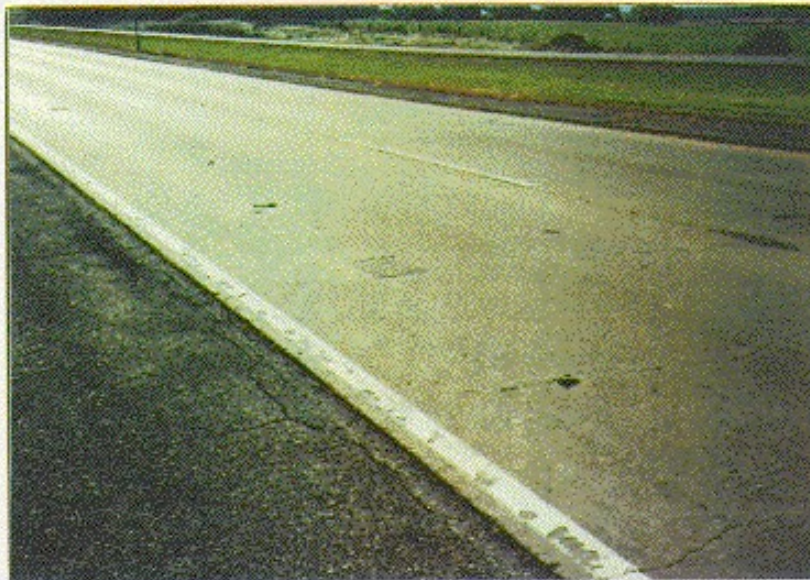
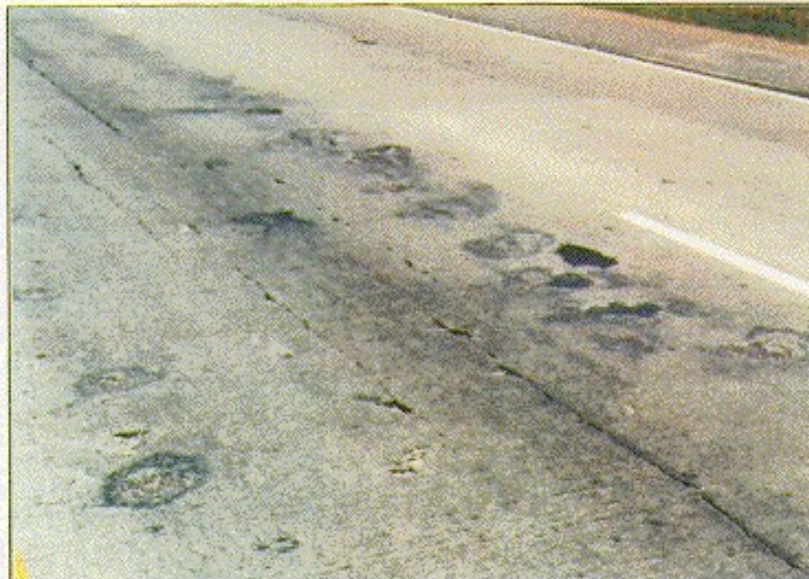
6. Spalls

The top picture is a section of CRCP with a few minor spalls in the background. Repair of spalls is difficult because full depth repair is not required. The bottom picture is a severely distressed section of CRCP with spalls caused by high steel, a full depth repair is required if this is a localized condition.

No repair is required for the top section of CRCP prior to the overlay. If the condition in the bottom photo is not localized and occurs over a significant amount of the project repair and overlay is the correct rehabilitation strategy. Partial depth patching with AC or PCC prior to placement of the AC overlay is required.

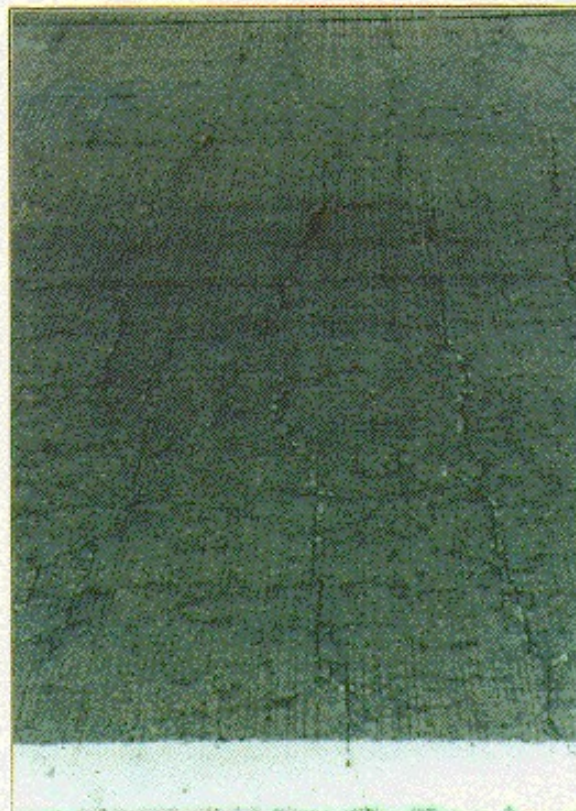
7. CRCP Advanced Distress

The following pictures are of CRCP in an advanced stages of distress. A repair is required on a short section of pavement with an isolated distress. It is also necessary for the repair to be adjacent to sound concrete. Because of the distressed condition of these pavements the areas in need of repair are likely to be extensive and the existence of sound concrete is unlikely. Therefore, extensive repair of these sections is not recommended from a practicality standpoint. Repairs should be minimized to those locations where it is absolutely required for placement of the overlay. These pavements warrant reconstruction of the pavement structure. However, if funding or some other factor requires that these pavements be rehabilitated the best option available would be placement of an AC overlay with minimum repairs being made to the concrete.

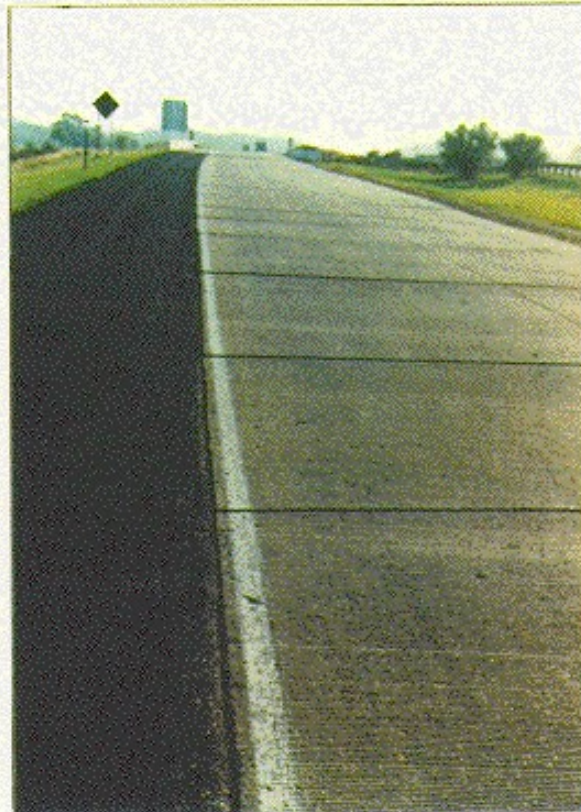
1. Faulted Joints

This section of highway is a faulted pavement. Although, it is faulted there are no visible distresses to the individual slabs. This section of highway is an excellent candidate for this rehabilitation strategy because faulting on the average is less than 1/2 inch.

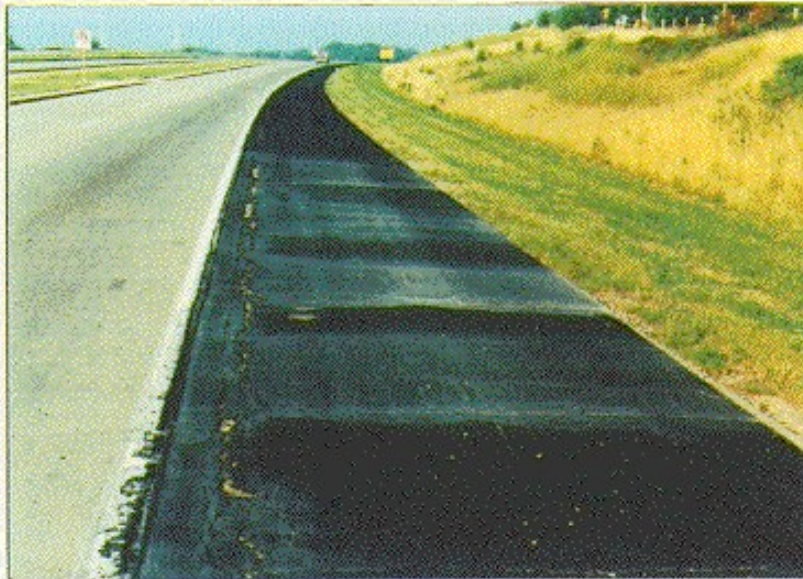
3. Pumping

The white staining on the shoulder in the above picture is an indication that pumping of the base is taking place. All necessary repairs to the concrete pavement that are required as previously outlined should be performed. The past practice of retrofitting a longitudinal edgedrain in this situation is not recommended. Current research efforts by the Department indicate that these retrofit drains are not draining water from the pavement structure and are not preventing recurrence of faulting in these type of pavements.

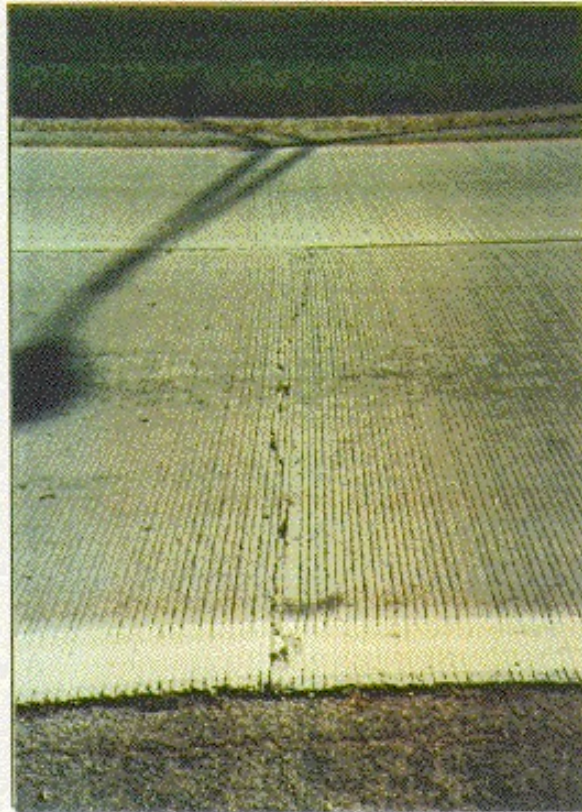
4. Crack

This crack is in good condition with a few minor spalls along the length of the crack. No repair is required. These spalls will be removed as part of the grinding operation.

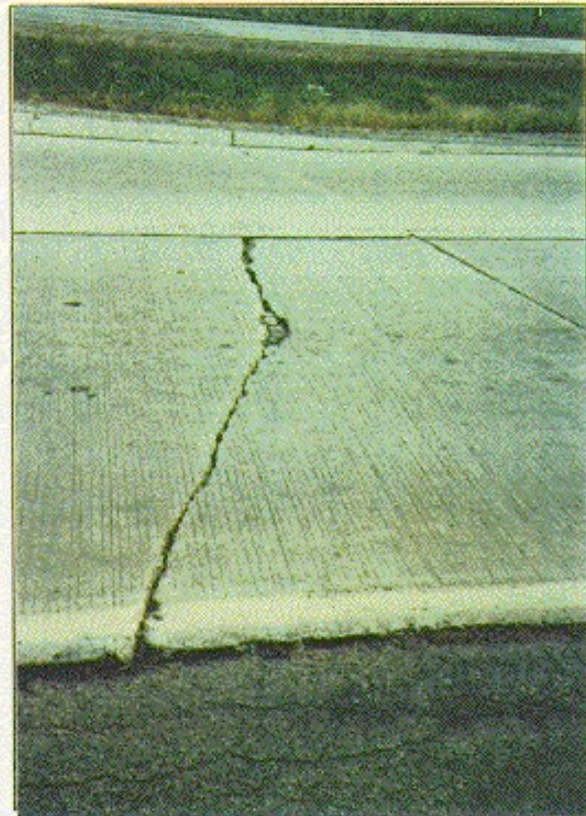
5. Transverse Crack

The above crack is faulted, spalled and has some secondary cracking running parallel to it. A replacement of this slab is required for this rehabilitation strategy.

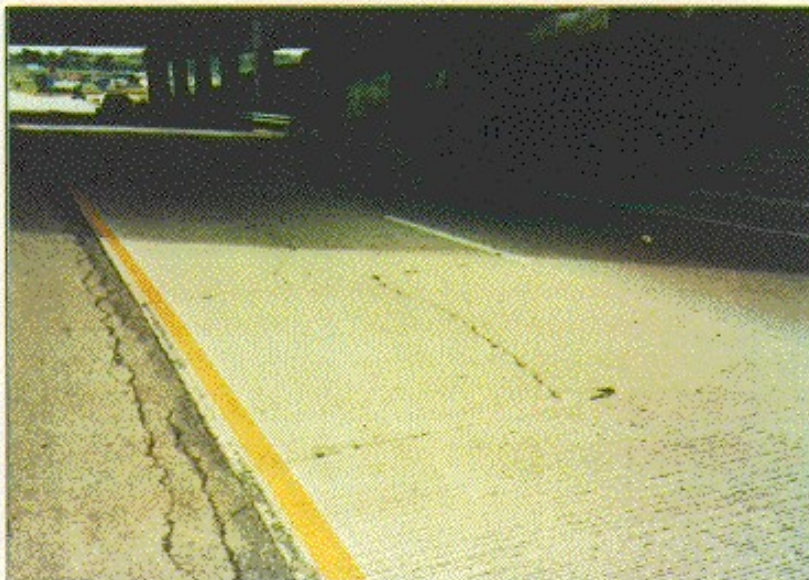
6. Longitudinal Cracking

Longitudinal cracks should be assessed from two standpoints. The first is the condition of the crack and secondly is the affect it has on ride quality. The cracks shown in the photo above are in successive slabs and have significant spalling. The slabs have also settled along the shoulder. This type of distress is an indication of a base or subgrade problem and a full depth repair is needed. However, it is not the intention of this manual to make a recommendation on subgrade or base repair.

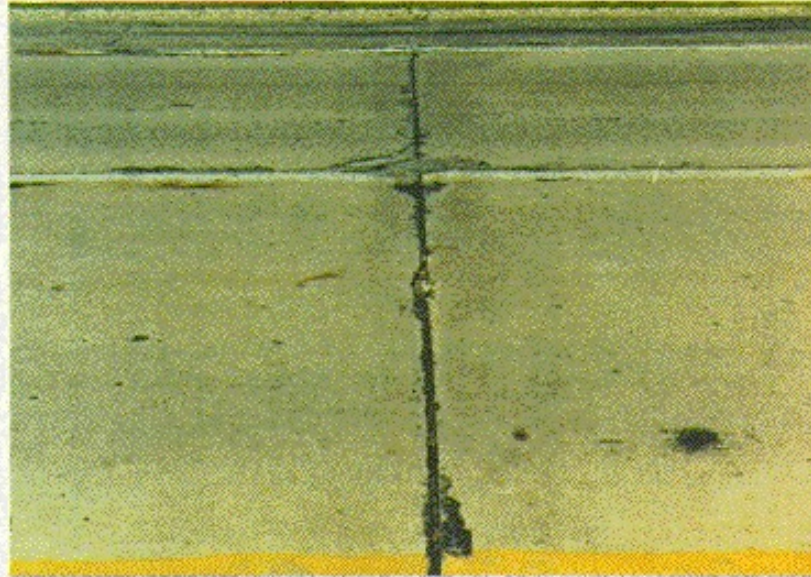
2. JOINT

This joint is in good condition. There is a minor amount of spalling at the surface along the joint, but this will be removed during the grinding operation. Note the asphalt sealant material around the joint and make sure this material is not masking more severe distresses. This joint should be left alone for this rehabilitation alternative.

This joint is in good condition and requires no additional treatment prior to overlay.

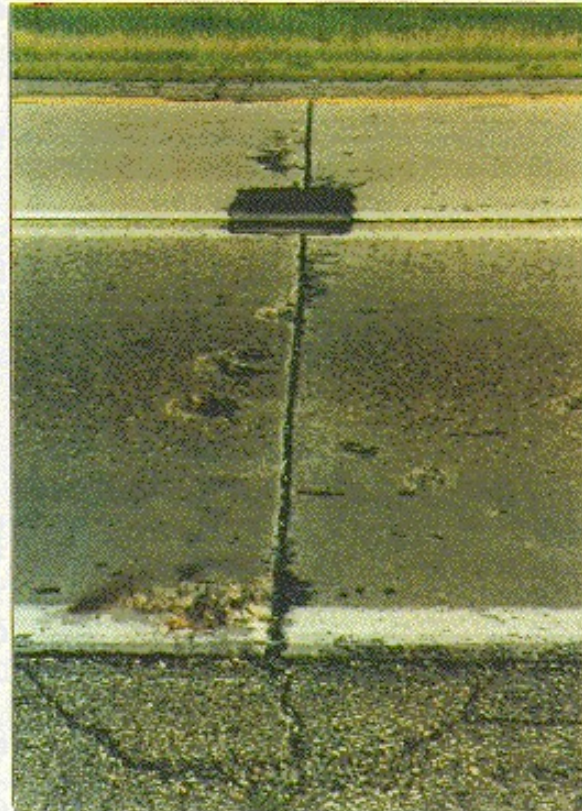
3. JOINT

This joint is in a more severe state of distress with the deep spalling at and around the joint. Also, the asphalt patch at the centerline is a sign of additional deterioration at the joint. The asphalt patch would not be compatible with the grinding operation. This joint should be selected for a full depth, full lane PCC repair under this rehabilitation alternative.

This joint is still in good condition for this rehabilitation alternative. The spalled areas should be jackhammered or ground to remove the delaminated concrete and filled with AC or PCC before placement of the overlay.

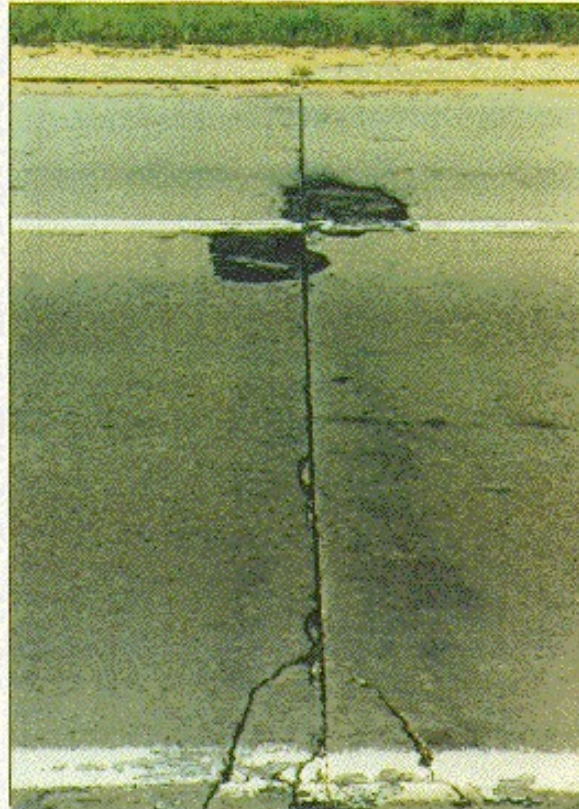
4. JOINT

This joint should be repaired as part of the this rehabilitation strategy. The broken pieces at the edge and center of the pavement are not compatible with the grinding operation.

As part of the resurfacing rehabilitation, this joint should be repaired due to the broken pieces at the edge and centerline of the pavement. Note the staining around the joint, this is an indication of age not of a significant D-cracking problem, (this pavement is 25 years old). If this were a significant D-cracking problem the staining and subsequent cracking would have occurred much earlier in the pavement's life. Caution should be exercised in using the staining as a basis for repair. When cracking around the joint begins to develop along with the staining a repair is warranted. However, a joint with staining only should be more closely investigated and compared to the overall condition of the joints over the entire project. From that engineering judgement should be used to decide on whether to repair or leave in place.

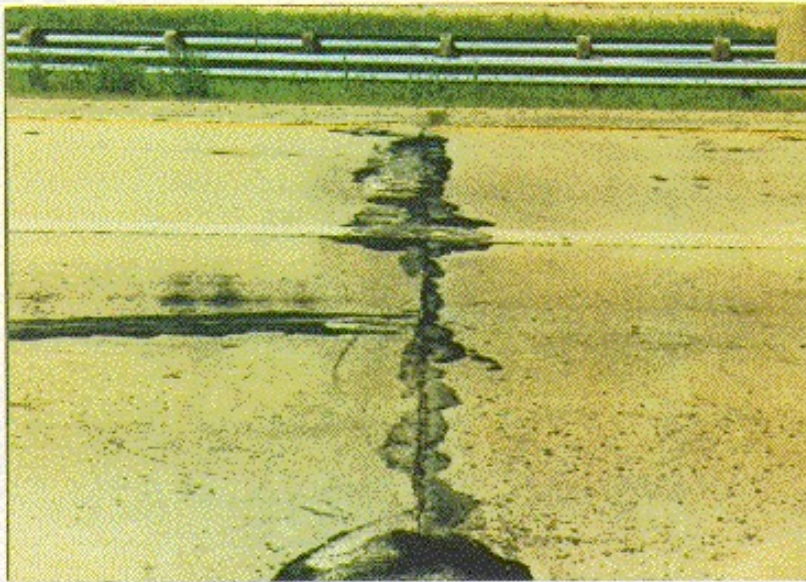
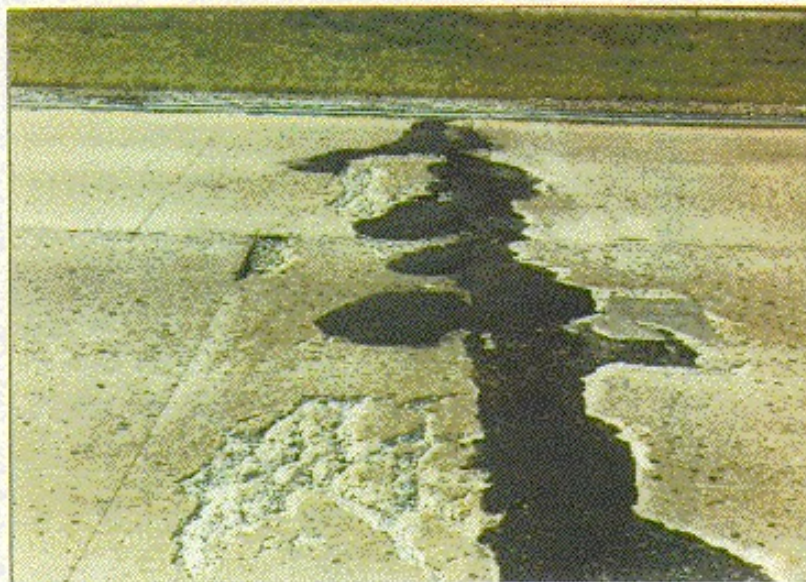
5. JOINT

These joints require full depth repair regardless of rehabilitation strategy. The repair should be completed as outlined for each rehabilitation strategy. There is parallel cracking along the joint and material is being removed by traffic.

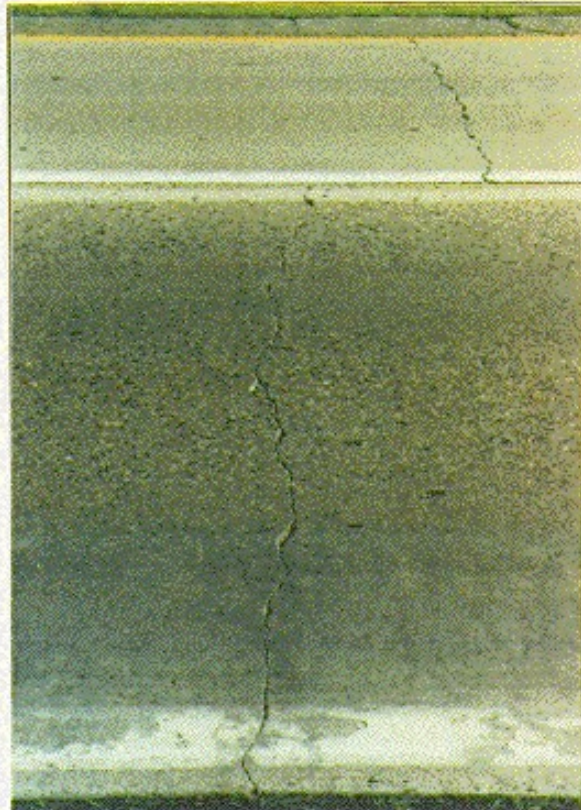
7. CRACK

This crack is in good condition with a few minor spalls along the length of the crack. These spalls will be removed as part of the grinding operation.

No treatment required prior to placement of the overlay.

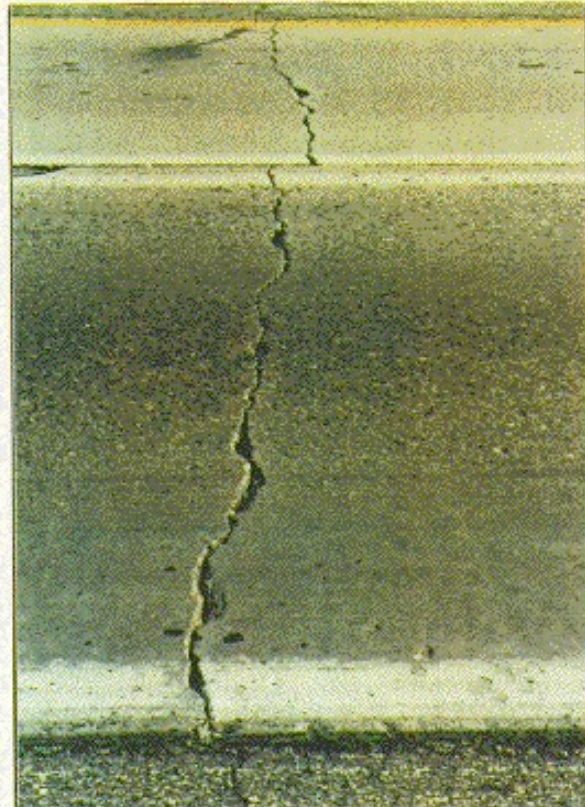
8. CRACK

This crack has more severe spalling, but is not faulted. A careful inspection of the spalled areas needs to be made. If the depths of these spalls are significant (1-3 inches) and additional visible distress is evident, the pavement should be repaired. This particular crack shows no distress other than the spalls. Therefore it should not be repaired as part of this rehabilitation alternative.

This crack would not require repair prior to overlay.

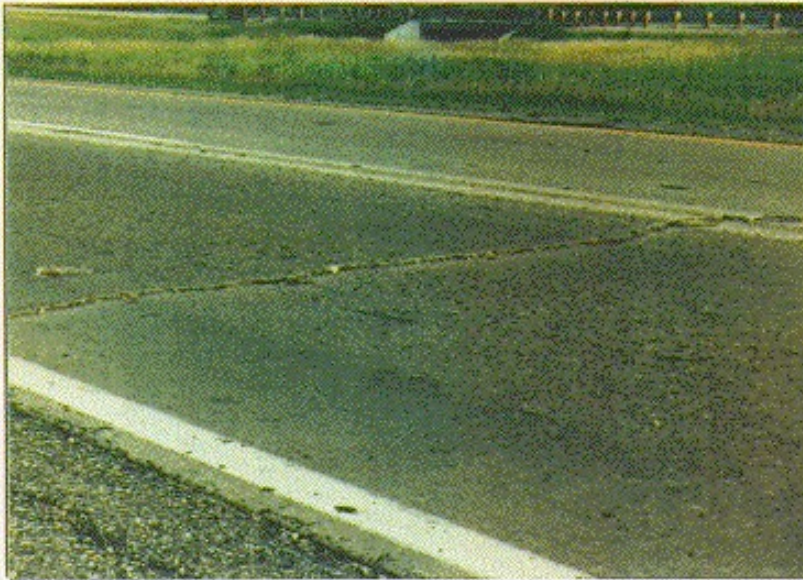
9. CRACK

This crack is in good condition with exception of the faulting. No repair is required prior to the grinding operation.

No repair is required as part of this rehabilitation strategy. Recent practice has been to construct a leveling course of AC prior to the binder course to aid in bridging significant faults.

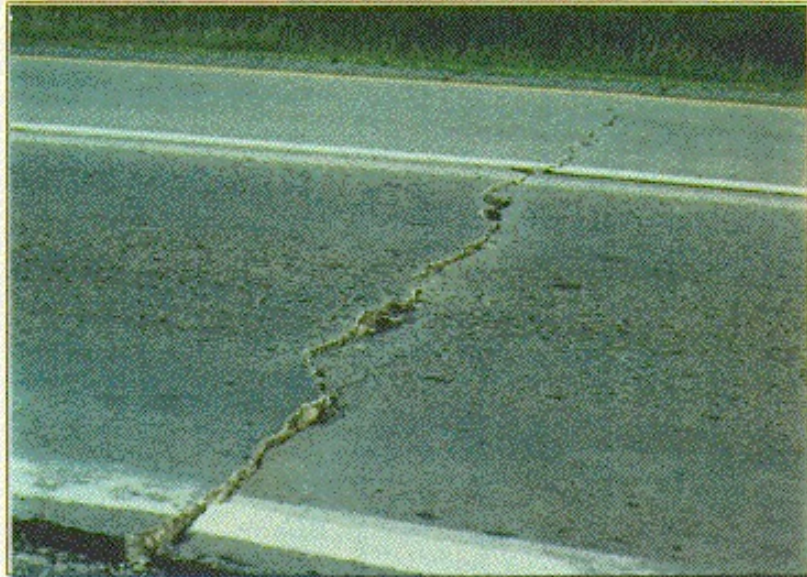
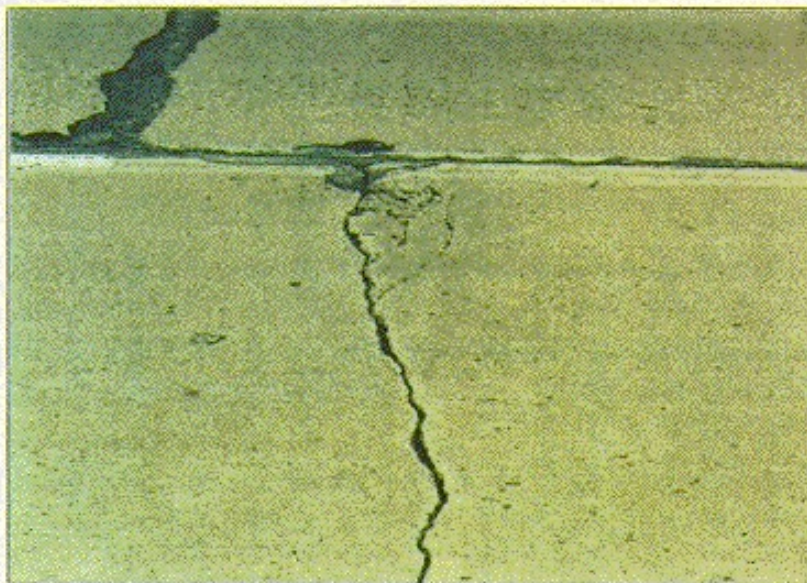
10. CRACK

Both of these cracks have secondary cracking adjacent to them that have formed large pieces of concrete. These pieces would be dislodged during grinding and form a large void at the surface. The secondary cracking is also an indication that more advanced distress has occurred. This crack should be repaired.

Due to the secondary cracking these cracks should also be repaired prior to the overlay.

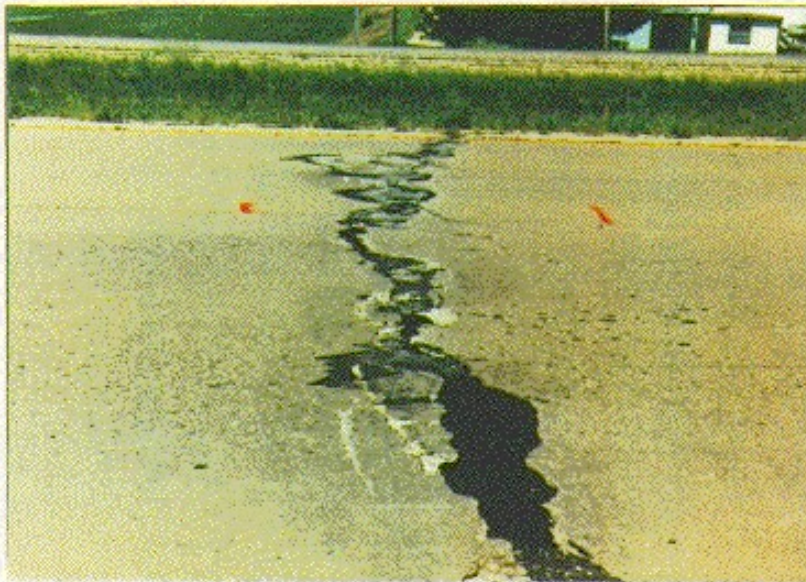
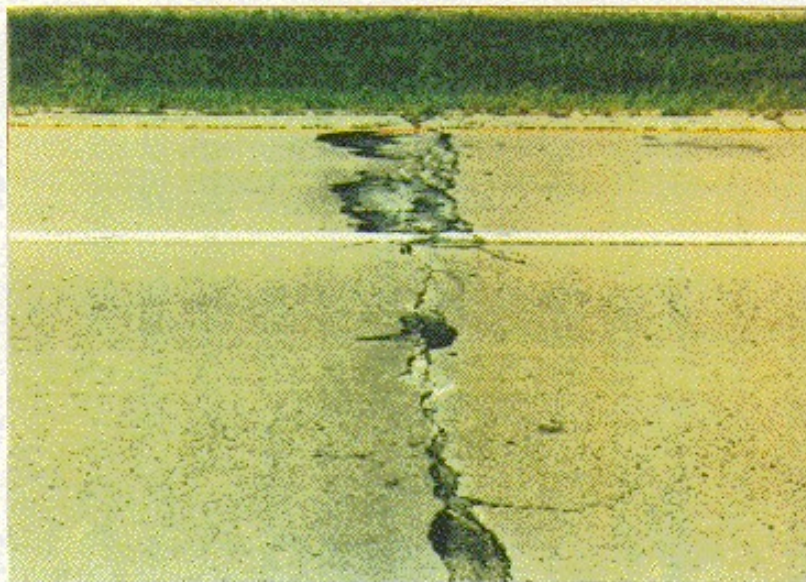
11. CRACK

These cracks require full depth repair regardless of rehabilitation strategy. The repair performed should be as previously outlined for each rehabilitation strategy.

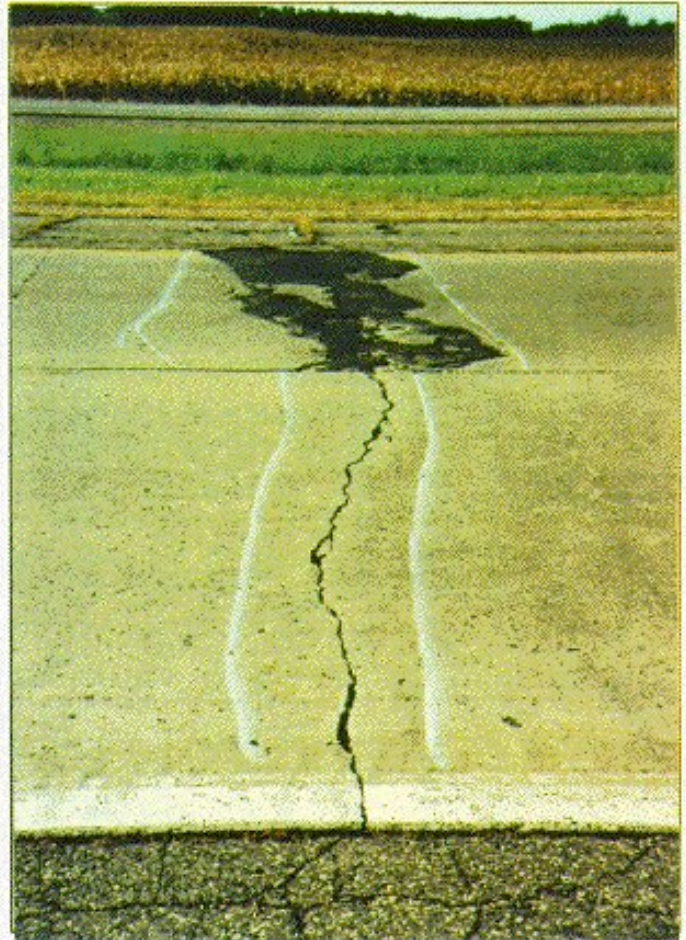
2. Single Transverse Crack

Both lanes require a full depth repair when using this rehabilitation strategy. It is obvious that the inside lane requires repair. However, the outside lane is not so obvious. As a general rule, any crack on a CRCP pavement with a crack width of 1/4-inch or greater is an indication that the steel has ruptured across the crack and load transfer has been lost. This makes that crack a location with the potential for additional distress to occur in a very short time. Therefore, a full depth repair is also recommended for the outside lane.

Under this rehabilitation strategy only the inside lane requires a full depth repair prior to placement of the overlay. The additional structure of the overlay should bridge the formation of additional distresses occurring at the crack in the outside lane.

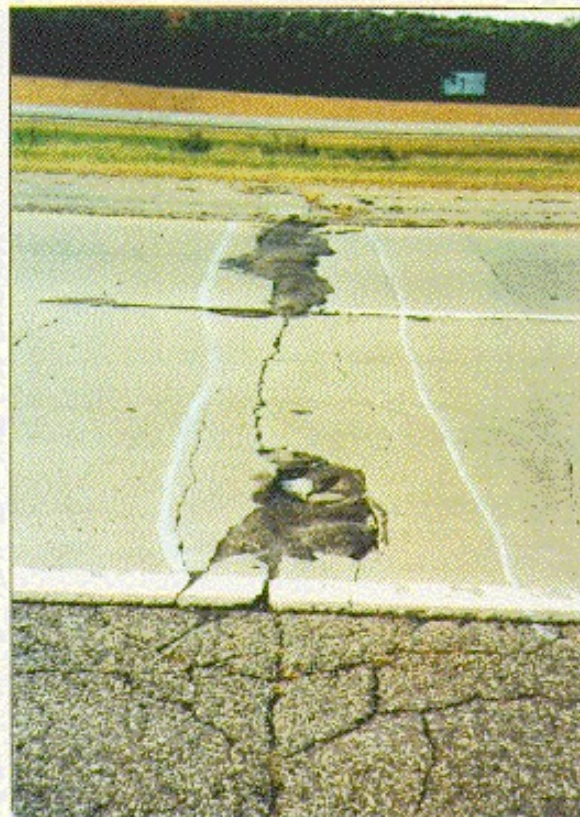
4. Multiple Transverse Cracks

The distress that has taken place at this location between cracks requires a full depth repair as part of this rehabilitation strategy. The steel has ruptured at the cracks and additional deteriorated areas have formed adjacent to the crack.

A full depth repair is also required for this rehabilitation strategy prior to placement of the overlay.

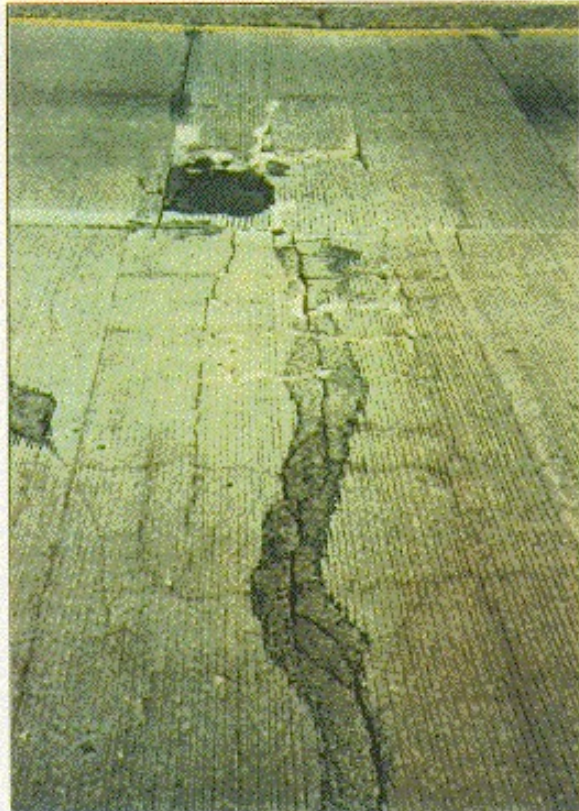
A full depth repair is required at this location regardless of rehabilitation strategy. The punchout failures at the centerline and far lane must be repaired prior to placement of the asphaltic concrete overlay.

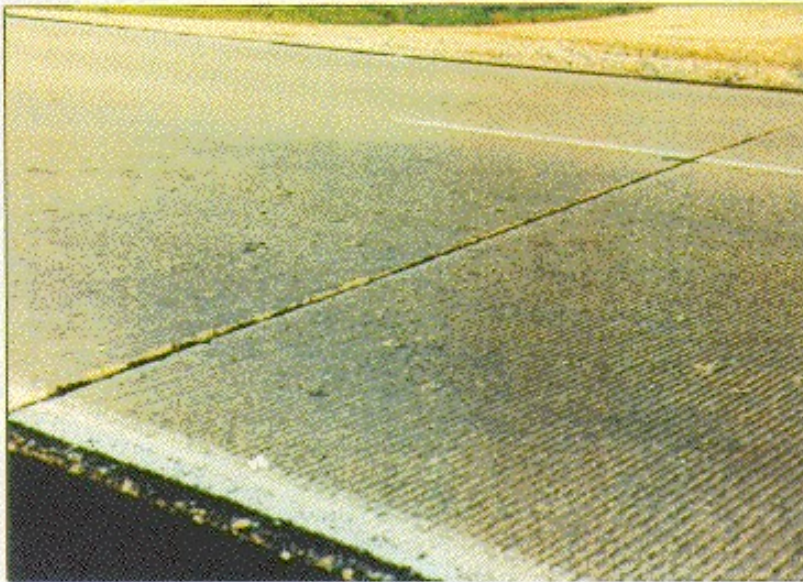
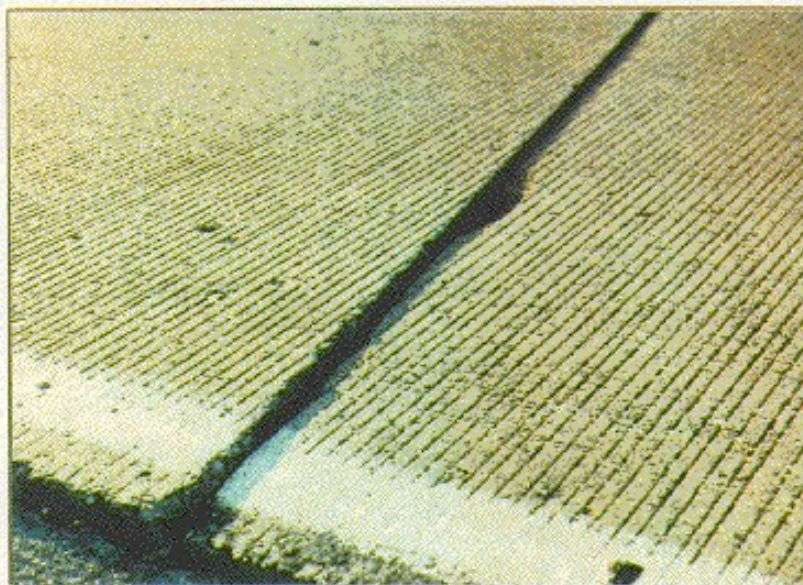
2. Faulted Joints

These pictures are supplements to the previous picture to aid in giving an indication of the degree of faulting on that particular section of highway.
